Manhole Inspection Summary

Manhole # S43EE_021MH

Location Address: **1707 E BIDDLE ST**

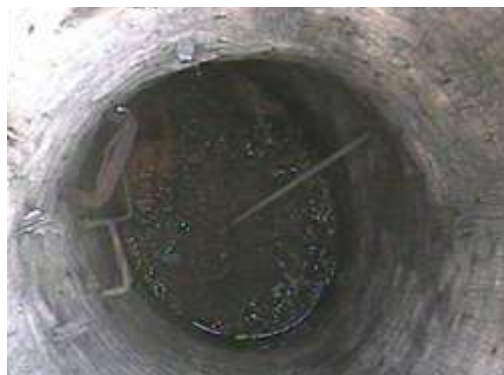
Top View

Count: **3** Missing: **2** ☒ **Corroded**

corroded steps

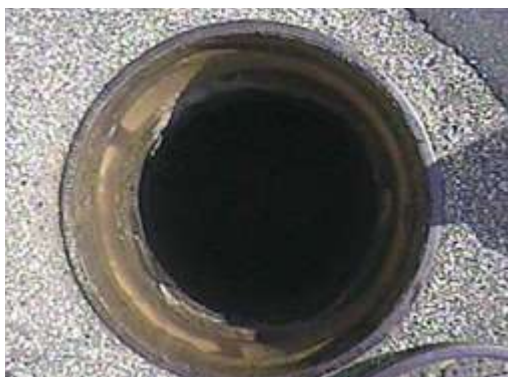
Defect 1

Condition: ☐ Sound ☒ **Cracked** ☐ Root Intrusion ☐ Loose Brick ☐ Deteriorated

cracked chimney

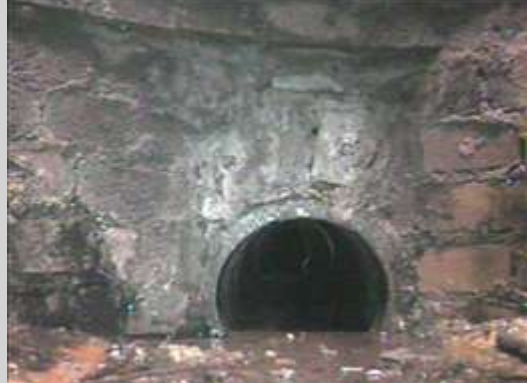
12 O'Clock Outflow

8 in. Circular Gravity Sewer
Pipe Out @ 12 O'Clock

Deposits: ☐ None ☐ Mud ☒ **Gravy** ☐ Debris ☐ Grease

Silt Depth: **1.5** (in.) Deposits Extent: **Light**
